NRL/MR/6110--02-8632

Green Thread Pipe Evaluation at Lualualei, HI and Jim Creek, WA

FINAL REPORT: GREEN THREAD PIPE EVALUATION AT LUALUALEI, HI AND JIM CREEK, WA

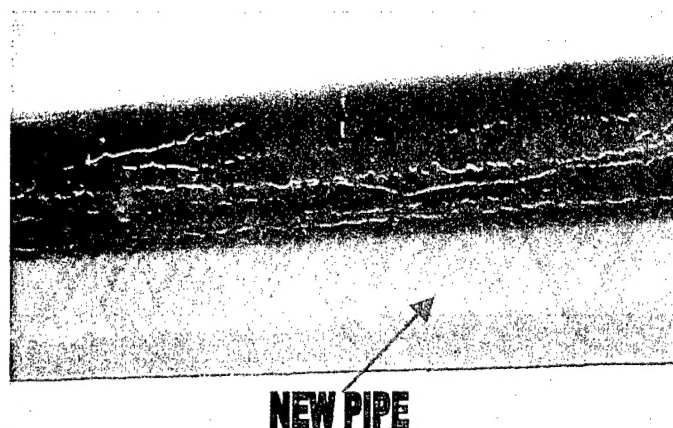
A darkening or a dark coating/deposit on the interior of the fiberglass tubing at the Lualualei site was observed in November 1997. The fiberglass pipe has a somewhat translucent light yellow/green color (bottom pipe) when new as seen in figure 1.

Figure 1. Examples of Green Thread pipe stored in warehouse at Jim Creek site, both new and a piece that had been in service.

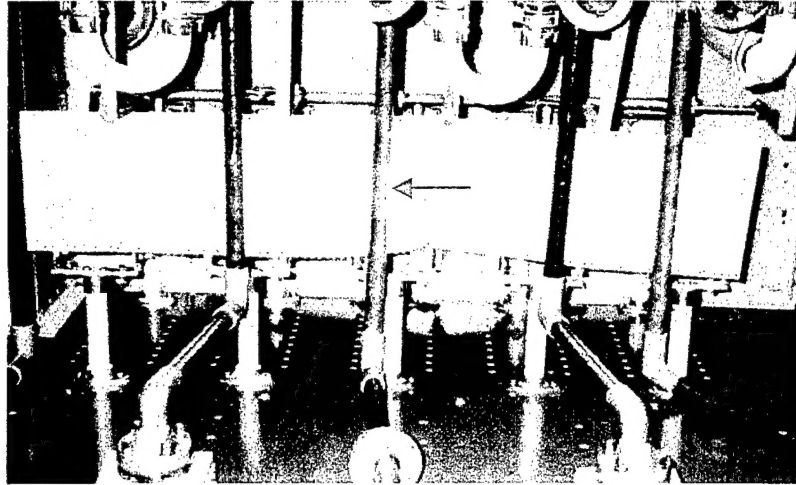
Figure 2. 1998 Photograph of the fiberglass pipe for PA 2 showing the color variations change in 1998 for PA2.

The coloration of the fiberglass pipe was photographed for use in future assessments of the aging process of the fiberglass pipe under VLF operating conditions. The discoloration of the pipe was mapped for all the cabinets. Figure 2 shows the color variations obtained for PA 2 in 1998. In general, the outlet pipes have a darker amber color than the inlet side pipes, but there were significant variations in the color for both inlet and outlet due to the variations in batch production of the pipe. There appeared to be color discontinuities in some of the piping where a splice has been used to join two pieces of pipe (indicated by arrow).

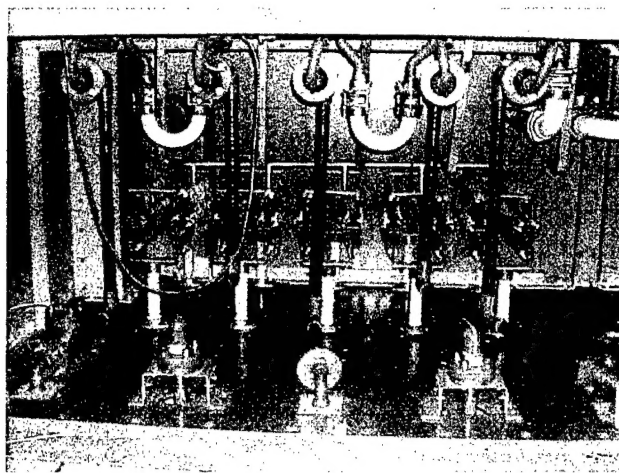
Figure 3. 2002 Photograph of the fiberglass pipe for PA 2 showing the color variations.

Figure 3 shows the same section of pipe (PA 2 left) photographed in April 2002. It is obvious that the Green Thread pipe has aged to a relatively uniform amber to dark amber color. There is no yellow green pipe coloration in the PA cabinets. The arrow in figure 3 denotes the location of the splice indicated in figure 2. The overall color of the

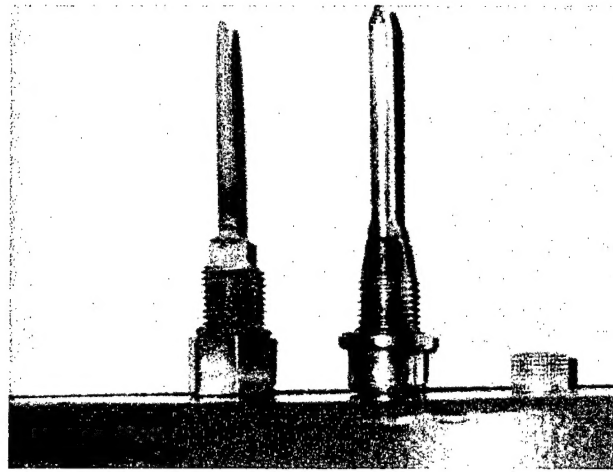
At that time, selected copper targets were removed from six of the piping segments to allow for the collection of water and also for the collection of swipe samples in the vicinity of the fiberglass pipe. This procedure was performed on pipe segments that were dark amber and those that were light green/amber in color so as to gain some variation, if it exists, in dissolved copper concentrations in the cooling water that is in intimate contact with the fiberglass pipe (keeping in mind that the water is mixed back in the PA tanks). Copper concentrations obtained from the swab samples ranged from 0.03 to 0.06 mg/l. In discussions with site personnel in May 2000, they stated that there was no increase in the erosion rate of the copper targets since the fiberglass pipe had been installed nor had targets been replaced since the installation of nitrogen generation system. As was the case with the Lualualei site, replacement targets were of a slightly different design so a comparison could not be made between the "in use" target and its replacement (see figure 4).

Figure 4. Targets from Jim Creek: on left side, old style target that had been in use for several years; new style target on right.

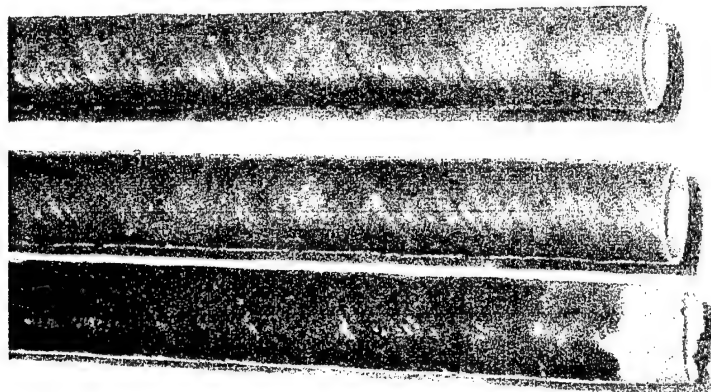
Figure 7 shows how different the color changes can be obtained for the Green Thread pipe over a period of time. Several pieces of Green Thread pipe were stored in

Figure 7. Green Thread pipe stored in warehouse at Lualualei site, March 2001.

the warehouse away from the transmission site at Lualualei. The temperature in the storage building at Lualualei was in the high 90s in March 2001. There is no air conditioning in that building but the room was filled with sunlight. We have an example of darker amber, medium amber and a medium yellow-green color. In this case, heat and UV light play a role in the color conversion. In contrast, several pieces of fiberglass pipe that were left at the Jim Creek site after installation over 4 years ago still have the light yellow/green and darker green color (Figure 1). There is no air conditioning for the Jim Creek storage site but the temperature in the storage area probably rarely exceeds 80° F. There is no incident sunlight in the Jim Creek storage room. The pipe is virtually “in the dark” unless someone enters the room and turns on the light or opens the outside storage doors. This pipe from Jim Creek is also an excellent example of the quality control for color. There is already a piece of pipe which exhibits a much darker quality (green) which will turn more quickly into a dark/amber color when subjected to increased temperatures.

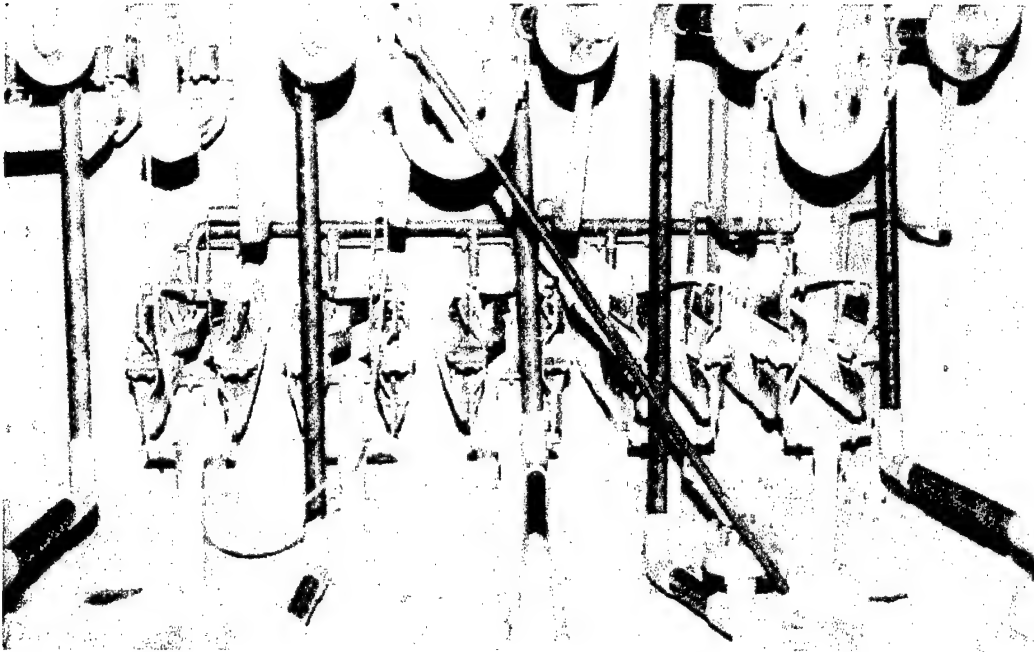
Figure 1. 1998 photograph of PA 1 (right side) fiberglass pipe showing color variations.

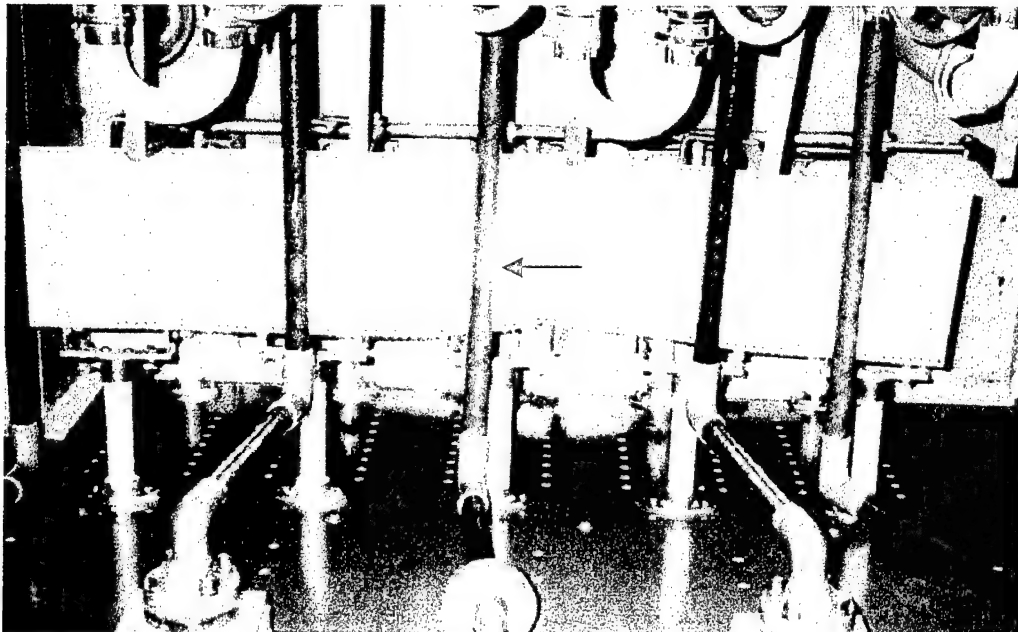
Figure 2. 1998 photograph of PA 2 (left side) fiberglass pipe showing color variations. Discontinuity of color (arrow) in center pipe is probably due to splice.

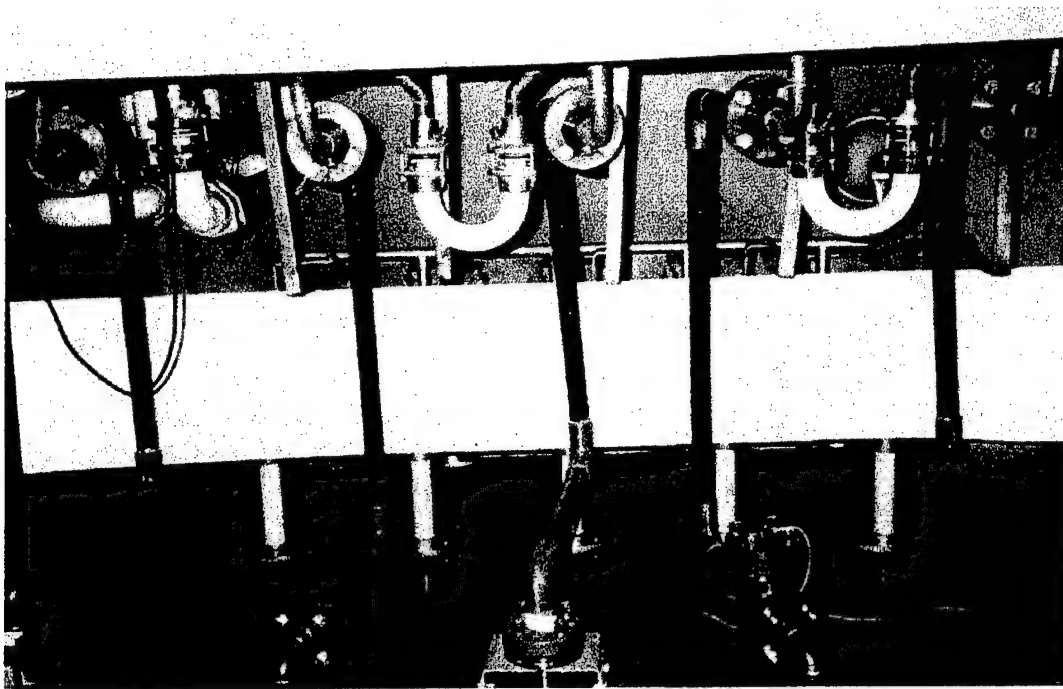
Figure 3. 2000 photograph of PA 1 (right side) fiberglass pipe showing that the color variations are almost nonexistent.

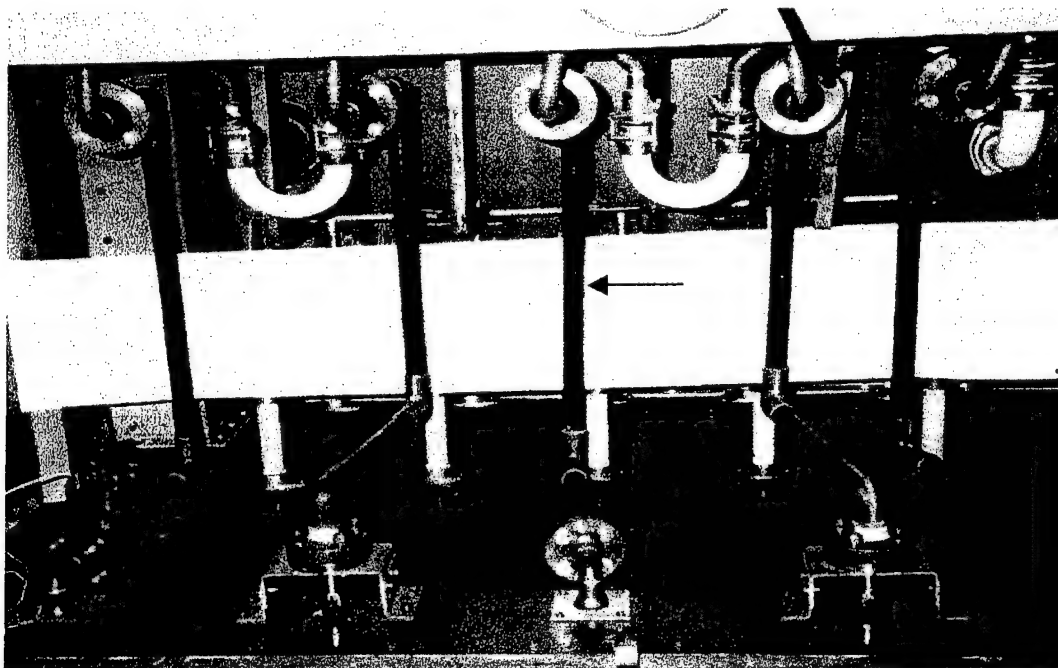
Figure 4. 2000 photograph of PA 2 (left side) fiberglass pipe showing color variations. Only slight indication of discontinuity (arrow) of color in center pipe shown in figure 2.

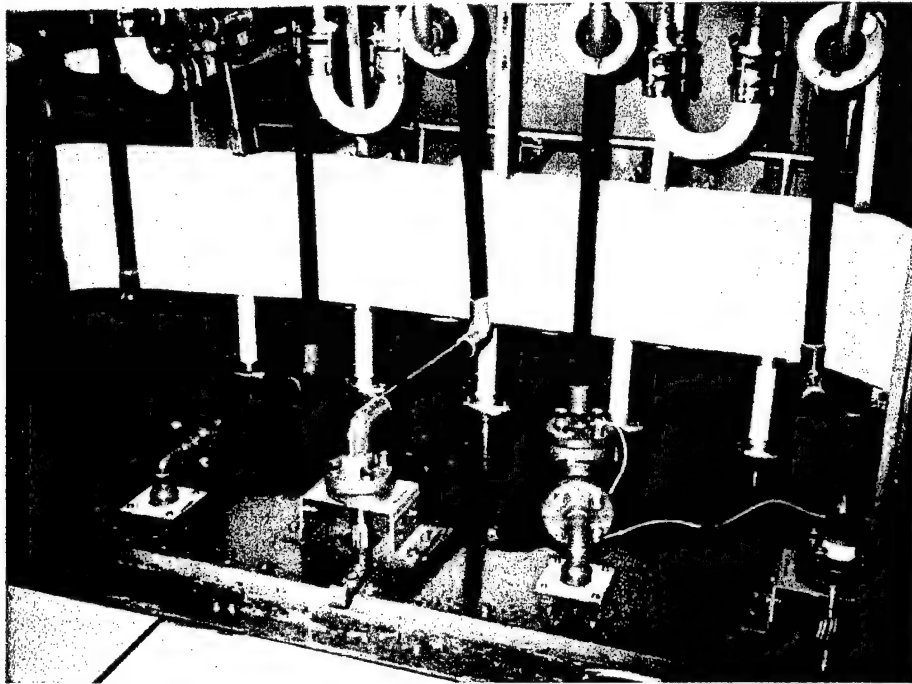
Figure 5. 2001 photograph of PA 1 (right side) fiberglass pipe showing that the color variations are almost nonexistent.

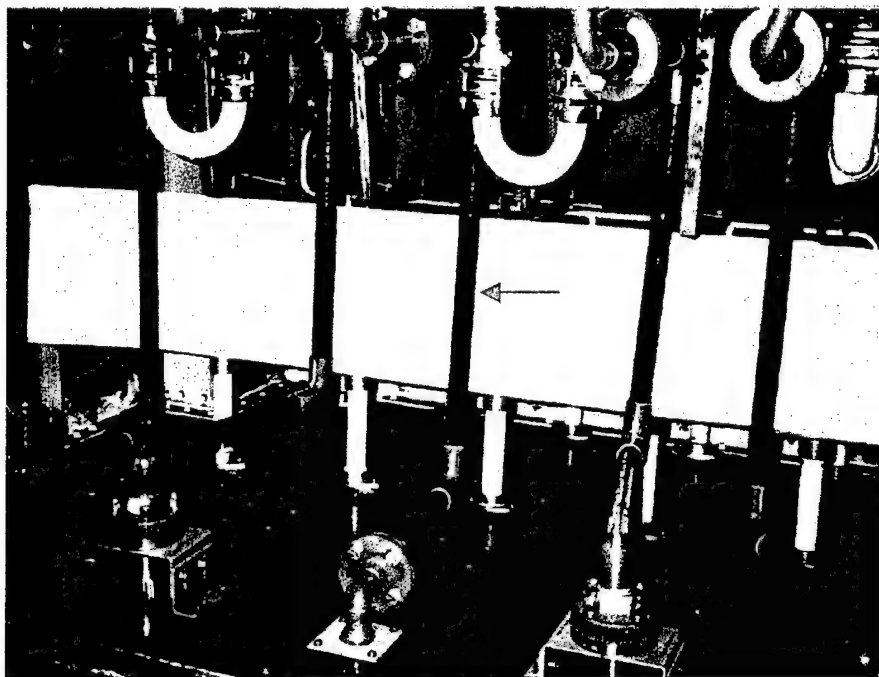
Figure 6. 2001 photograph of PA 2 (left side) fiberglass pipe showing no color variations. Arrow indicates where discontinuity occurred in Figures 2 and 4.

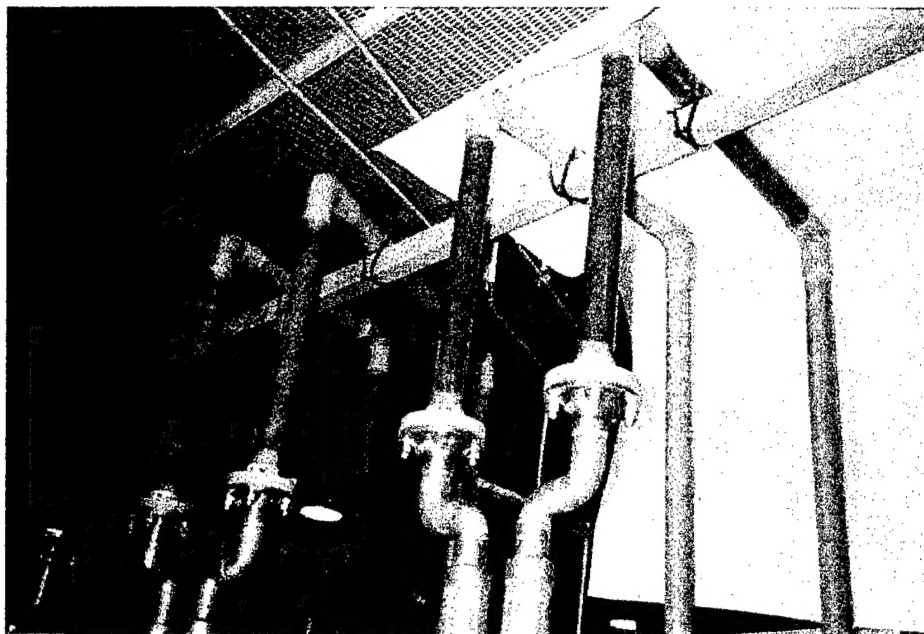
Figure 9. 1998 photograph of fiberglass pipe discoloration for 13V1001 (starboard side)

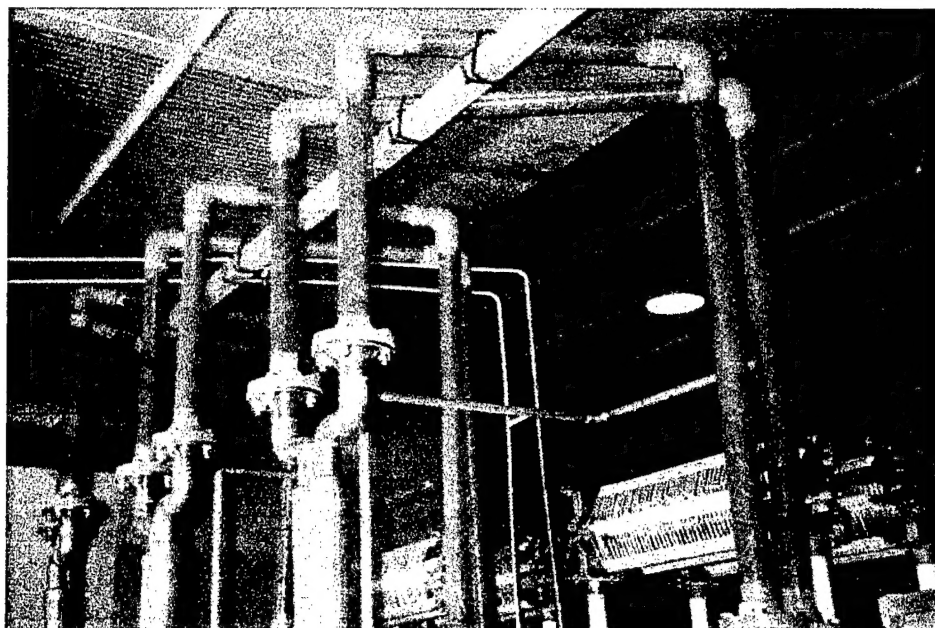
Figure 10. 1998 photograph of fiberglass pipe discoloration for port side PAs. Relatively even color distribution as compared to figure 7.

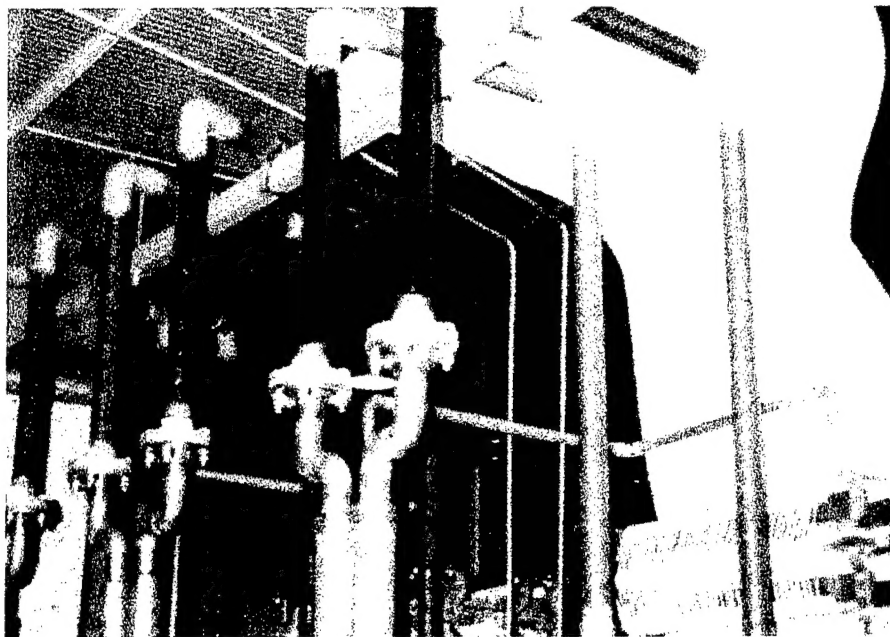
Figure 11. 2000 photograph of fiberglass pipe discoloration for 13V1001 (starboard side)

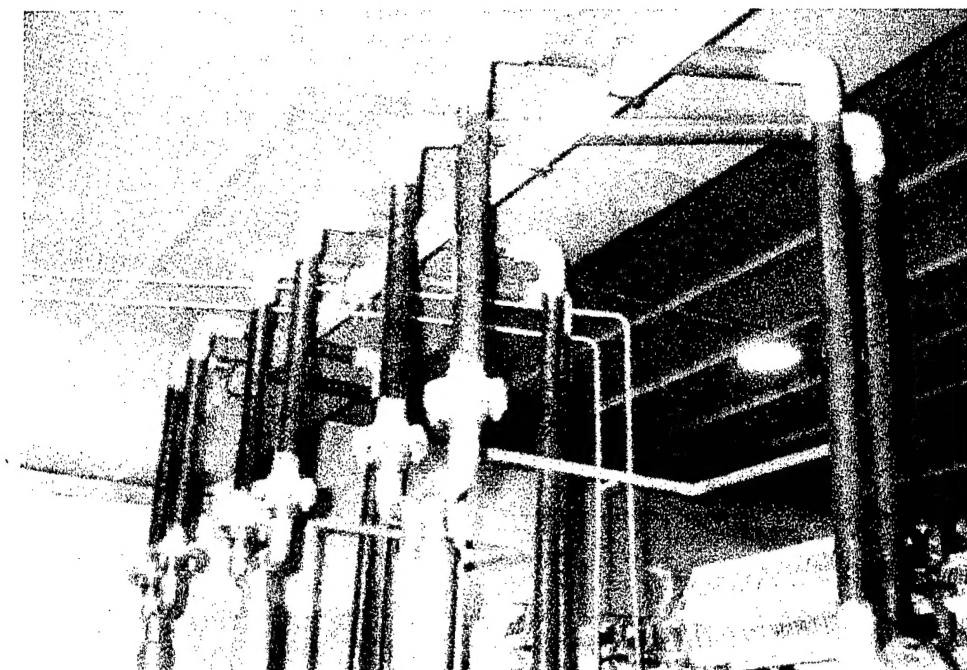
Figure 12. 2000 photograph of fiberglass pipe discoloration for port side PAs.

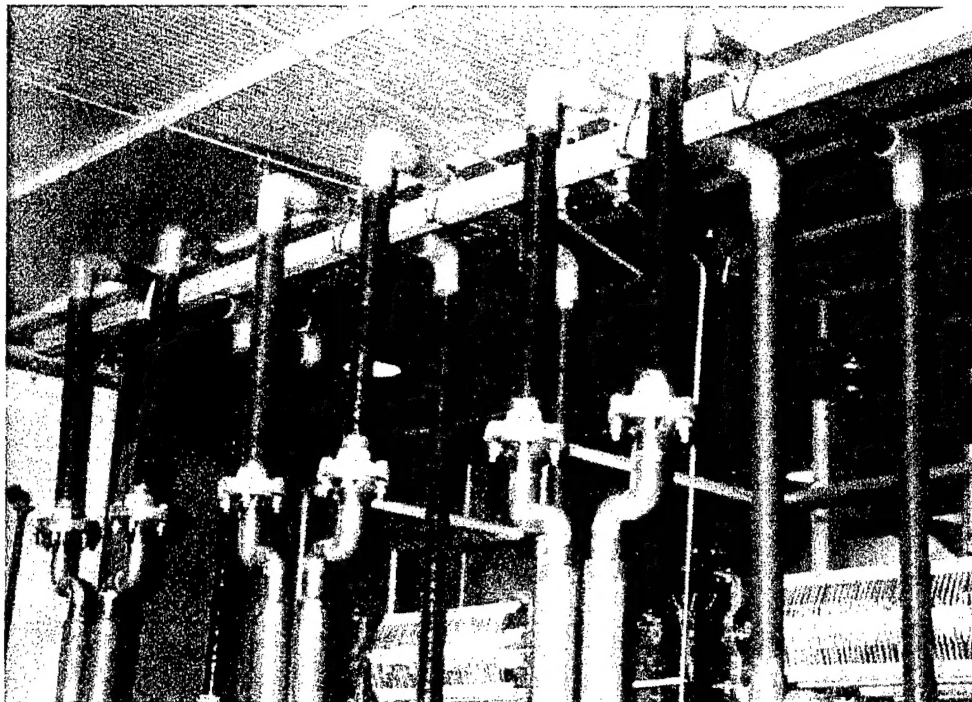
Figure 13. 2001 photograph of fiberglass pipe discoloration for 13V1001 (starboard side).

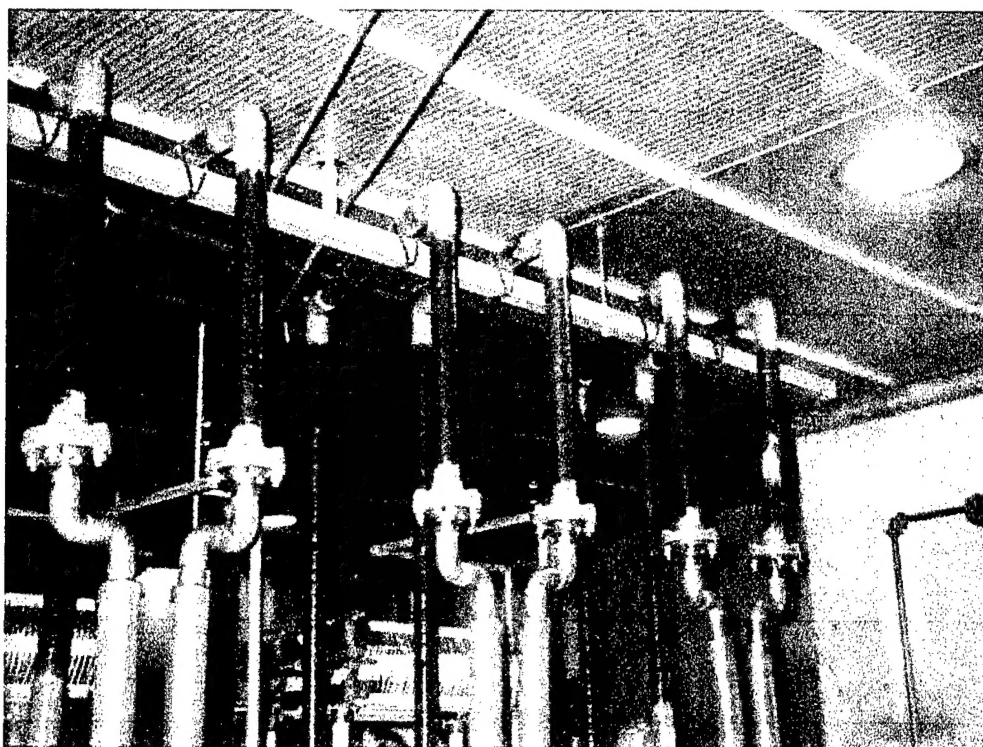
Figure 14. 2001 photograph of fiberglass pipe discoloration for portside PAs.

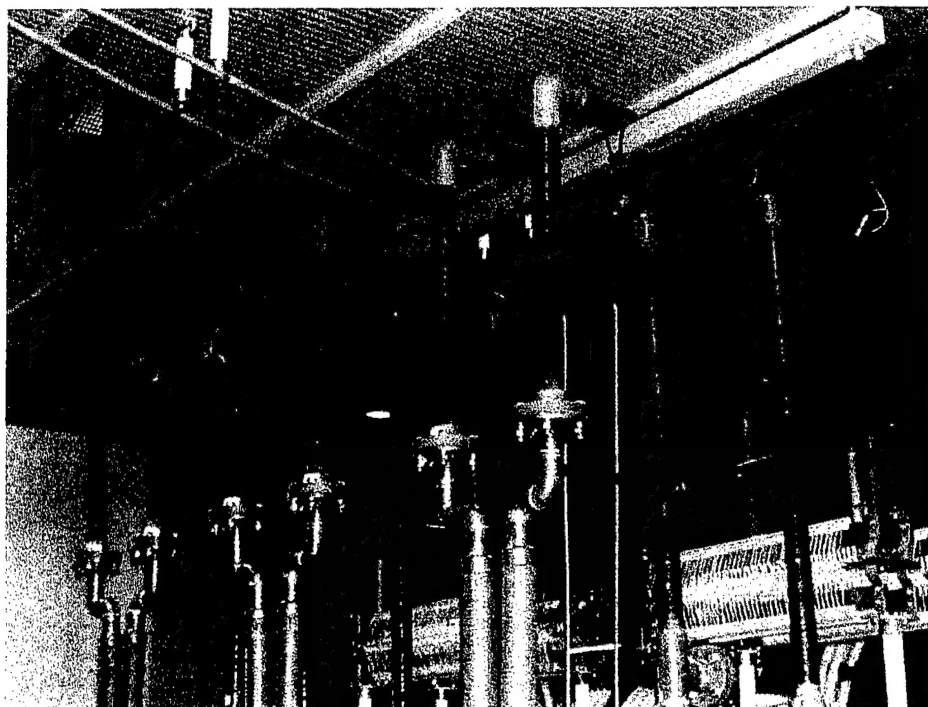
Figure 15. 2002 photograph of fiberglass pipe discoloration for 13V1001 (starboard side).

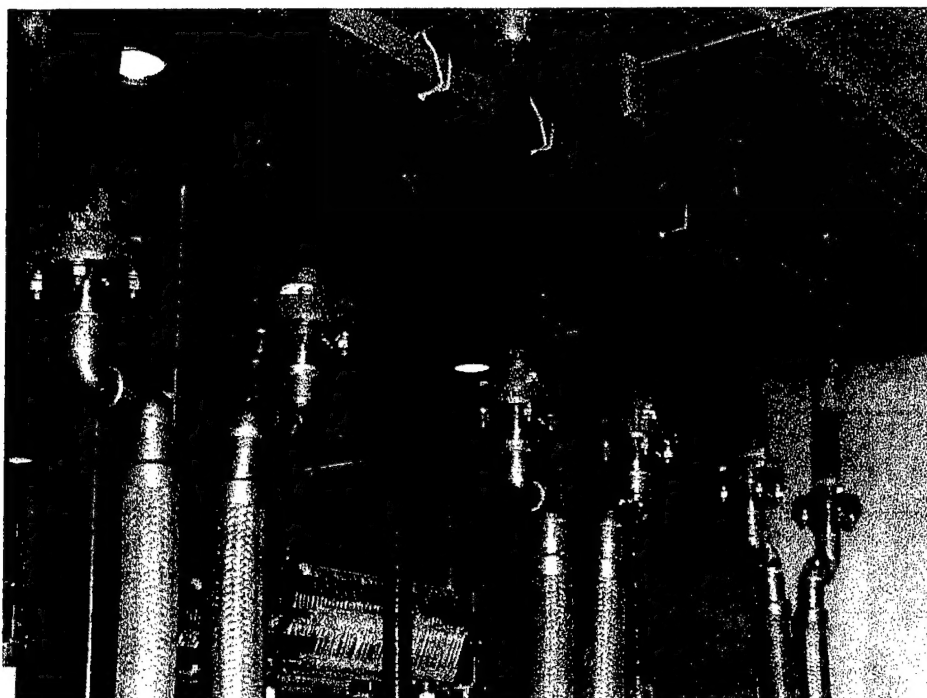
Figure 16. 2002 photograph of fiberglass pipe discoloration for portside PAs
